Technical Bulletin

Number:
 022

Subject/Key Words:	Low temperature filter housing mounting bracket upgrade kit
Classification:	■ Informational □ Mandatory □ Safety Alert □ PM Impact
	□ Warranty Impact □ Purchase Parts □ No Charge For Parts expires// Reference this TB# when ordering NC parts.
Applicable Akrion Procedures:	none
Parts/Reference Documents:	224375-001 universal filter housing mounting bracket field upgrade kit. (All ECTFE materials)
Attachments:	Diagram – see page 2.

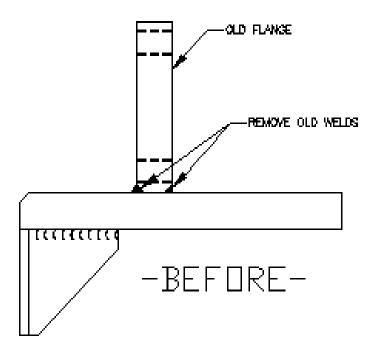
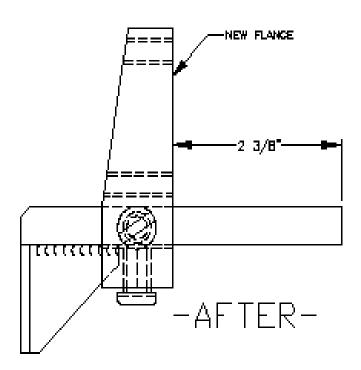
TB 22 - Attachment page 2.

Issue: All low temperature single and dual filter housing assemblies are mounted with four

screws per bowl - affixed to a tapped mounting plate which is in turn welded to a plenum side-wall supporting bracket. Reported field data has shown that some, not

100%, of the filter housing mounting plate-to-bracket welds have cracked.

Symptoms: Filter housings able to move (detached) with respect to the side-wall bracket(s).

Solution: Replace bracket as needed (one per housing): Drain, flush, and remove filter

assembly as needed. Remove original mounting plate, scrape/deburr old weld buildup flush, slide new mounting plate onto support bracket (slope side towards the wall), position and secure with the three screws. Re-install filter housing

assembly and test for leaks.

As part of CIP, gussets have been added to new manufactured filter housing mounting assemblies. Refer to page 2 for a diagram of the upgrade kit application.
