Technical Bulletin

Number: 028
Date Issued: 09/11/03
Expiration Date: 09/11/04

Subject/Key Words:	Loose main power connections may result in equipment failures.		
Classification:	<input type="checkbox"/> Informational	<input checked="" type="checkbox"/> Mandatory	<input type="checkbox"/> Safety Alert
	<input type="checkbox"/> PM Impact	<input checked="" type="checkbox"/> Warranty Impact	<input type="checkbox"/> Purchase Parts
Applicable Akrion Procedures:	HS0067 Akrion Lock-out Tag-out Program		
Parts/Reference Documents:	Ref. Power Plate "D" drawing # 212518 – provided in all Blueprints manuals for GAMA series 3 electrical tower # 212507-001.		
Attachments:	Page 2. Visual reference of hex lugs to be tightened on CB1 and K100

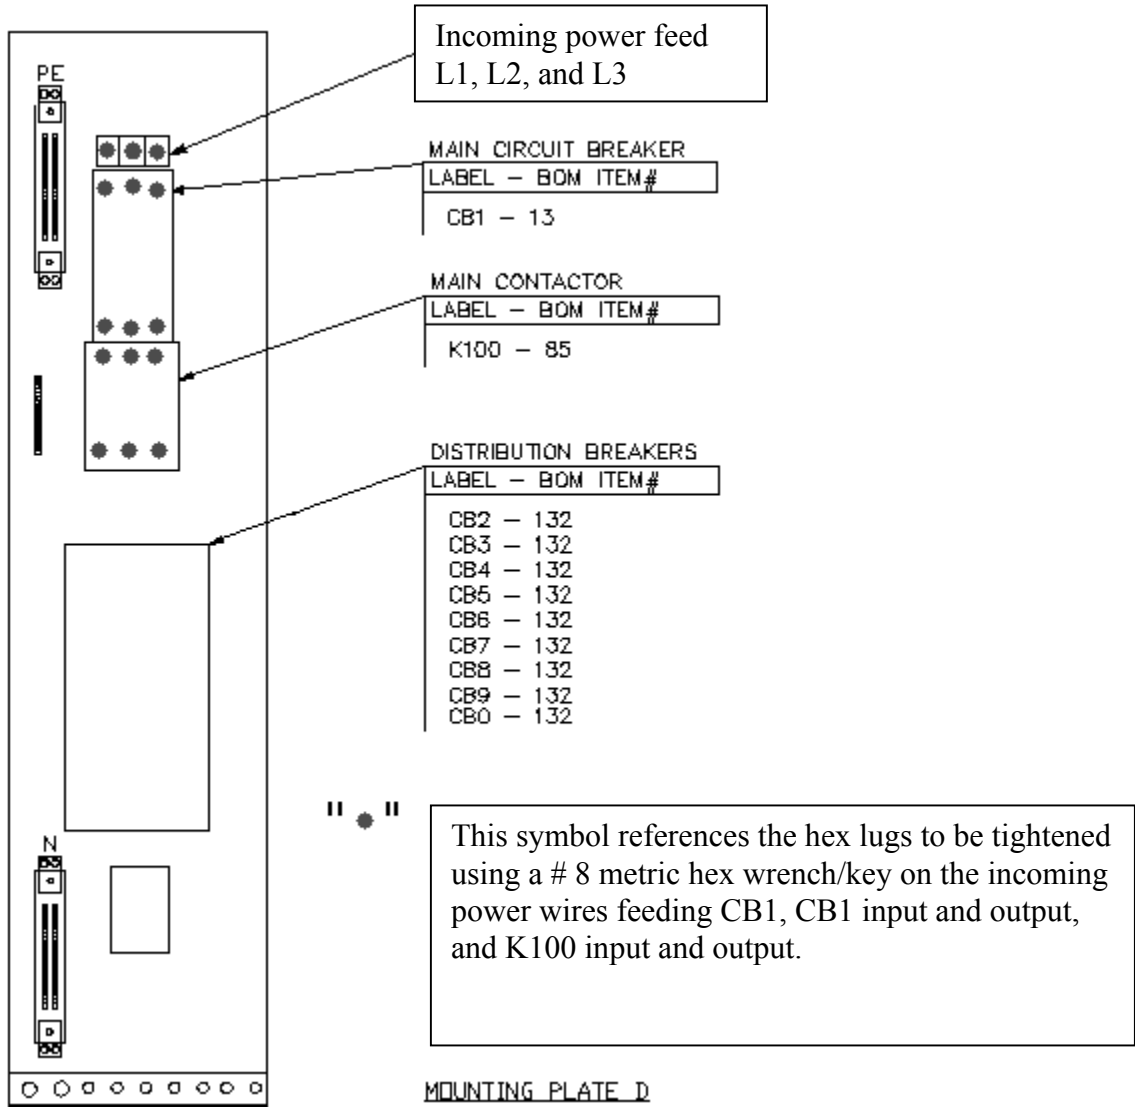
Issue: Loose hex-lug power bus connections on the main power feed wires (L1, L2, and L3) and input/output lugged connections of both the main circuit breaker CB1 and main contactor K100, have been isolated as sources for voltage anomalies which have led to component failures in the main power branch circuits.

Symptoms: Known failures: 1. UPS failures. 2. Robot system fails to reset or exhibits current limiting.

Test/Validate: On towers having CB1 and K100 conjoined as shown in drawing 212518 all input and output power bus lugs must be confirmed as properly tightened. Disconnect facility power to the tower, test for no 208VAC leg-to-leg for L1, L2, and L3, and LOTO facility feed to CB1. Shut off CB1. Tighten all lugs as shown on page two using a metric #8 hex wrench/key. Use non-round ended hex wrench if possible. DO NOT over-torque and strip the threads. Poor connections will be obviously loose. After all lugs have been properly tightened, remove LOTO and restore power.

Solution: Tower vendor will QC all subsequent units to ensure lugs are tight and to add thread lock and vibration detection lacquer to each lug.
