Technical Bulletin

Number: 034
Date Issued: 11/12/03
Expiration Date: 11/12/04

| Subject/Key Words: | GAMA Plenum Door Latches & Handles |

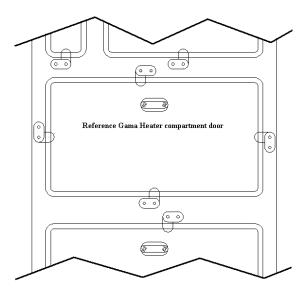
<u>Issue</u>: Plenum door latches and handles may wear/break over time.

Symptoms: Worn or broken door latches may cause the following:

- Poor sealing of the plenum doors.
- Pneumatic Interlocks to not engage completely.

As part of the Akrion Continuous Improvement Program (CIP), the latches and handles have been redesigned and are available as a purchasable kit. The kit can be ordered via Akrion part # 221898-001 through Akrion's Parts Logistics department. One kit is needed per module and fits every type of plenum. Below is an example layout of the new latches and handles.
