Technical Bulletin

Number: 080
Date Issued: 02/04/11
Expiration Date: n/a

Subject/Key Words:	Fire System CO2 Actuator Inadvertent Discharge			
Classification:	<input type="checkbox"/> Informational	<input checked="" type="checkbox"/> Mandatory	<input checked="" type="checkbox"/> Safety Alert	<input type="checkbox"/> PM Impact
	<input type="checkbox"/> Warranty Impact	<input type="checkbox"/> Purchase Parts	<input type="checkbox"/> No Charge For Parts expires ___/___/___. Reference this TB# when ordering NC parts.	
Applicable Akrion Procedures:	None			
Parts/Reference Documents:	Actuator: 216589-001, 00013216-00, 4090861A-00			
Attachments:	ANSUL Bulletin No. 5706

DATE: November 17, 2010
TO: Authorized ANSUL High Pressure Carbon Dioxide System Distributors
FROM: Quality Assurance
SUBJECT: Inadvertent Discharges of High Pressure Carbon Dioxide Systems

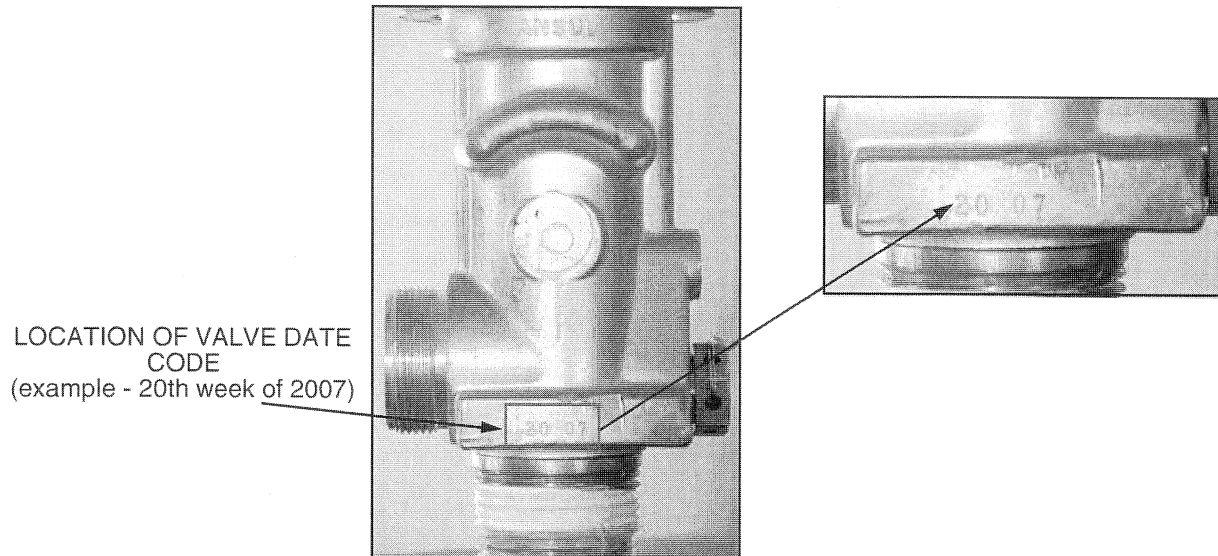
Identifying the Date Code

High Pressure CO₂ valves with a date code range of 10-07 to 06-08.

The date code is located on the flat opposite of the valve outlet. The date code represents the **week and year** the valve was manufactured.

Please follow the Pneumatic Actuation Port Plug Replacement Procedure on Page 3 for any ANSUL High Pressure CO₂ valves with a date code range of 10-07 to 06-08 that you identify.
