Technical Bulletin

TB Number: 103
Date Issued: 10/26/2016
Expiration Date: Na

Subject/Key Words:	Conductivity Sensor/Housing PM Requirements and Parts ID			
Classification:	<input checked="" type="checkbox"/> Informational	<input checked="" type="checkbox"/> Mandatory	<input type="checkbox"/> Safety Alert	<input checked="" type="checkbox"/> Preventive Maintenance Impact
	<input type="checkbox"/> Warranty Impact	<input type="checkbox"/> Purchase Parts	<input type="checkbox"/> No Charge For Parts expires ___ / ___ / ___. Reference this TB# when ordering NC parts.	
Application/Product Line:	GAMA, Rearmount

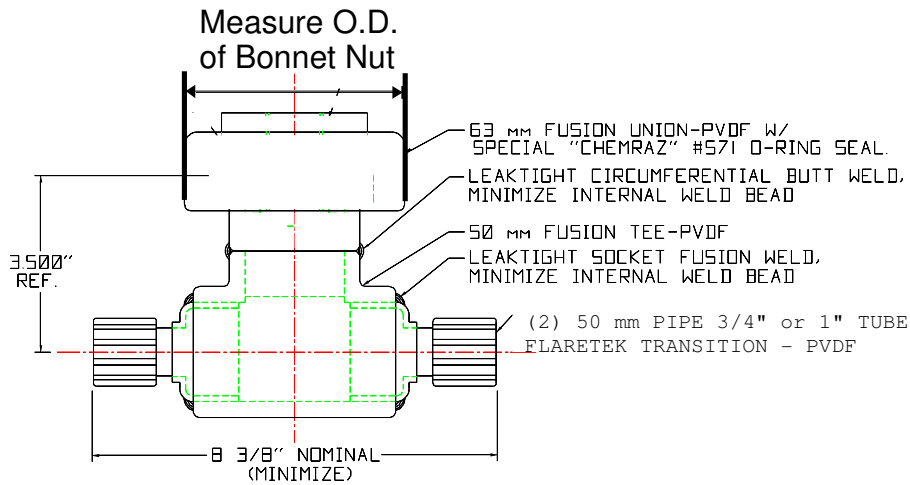
Identifying MAN009154/55 Housings

To determine if you have useable MAN009154 or MAN009155 housings, measure the outside diameter of the bonnet nut. It should measure 4.37".

Old, unusable MAN000870 and MAN000871 housings will measure 3.58". These housing are too narrow to accept the new sensors. They must be replaced.

O.D. MAN009154/55 = 4.37" CAN BE REUSED

O.D. MAN000870/71 = 3.58" MUST BE REPLACED
