Technical Bulletin

Number: 106
Date Issued: 06/07/16
Expiration Date: n/a

Subject/Key Words:	Mini-environment Cracked Door Corners		
Classification:	<input checked="" type="checkbox"/> Informational	<input type="checkbox"/> Mandatory	<input checked="" type="checkbox"/> Safety Alert
	<input type="checkbox"/> Warranty Impact	<input type="checkbox"/> Purchase Parts	<input type="checkbox"/> PM Impact
Applicable Akrion Procedures:	None		
	<input type="checkbox"/> No Charge For Parts expires ___ / ___ / ___. Reference this TB# when ordering NC parts.

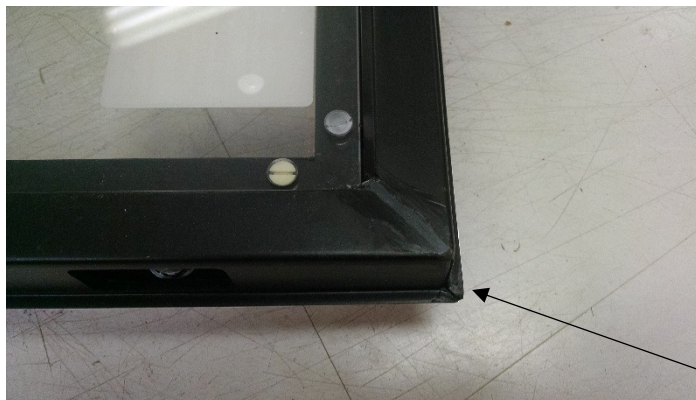
Issue: Single pane HuntAir/Synetics upper clear or smoked plastic mini-environment door corner joints can crack open.

Example of welded joint repair

Best: Plastic weld the window frame corners to create a solid corner and eliminate door flex.
Example: PVC weld rod, black.
